ASBESTOS INVESTIGATION REPORT

CAN CLAY FACILITY
402 WASHINGTON STREET
CANNELTON, INDIANA 47520

ATC PROJECT NO. 170IRPC08H

FEBRUARY 7, 2020

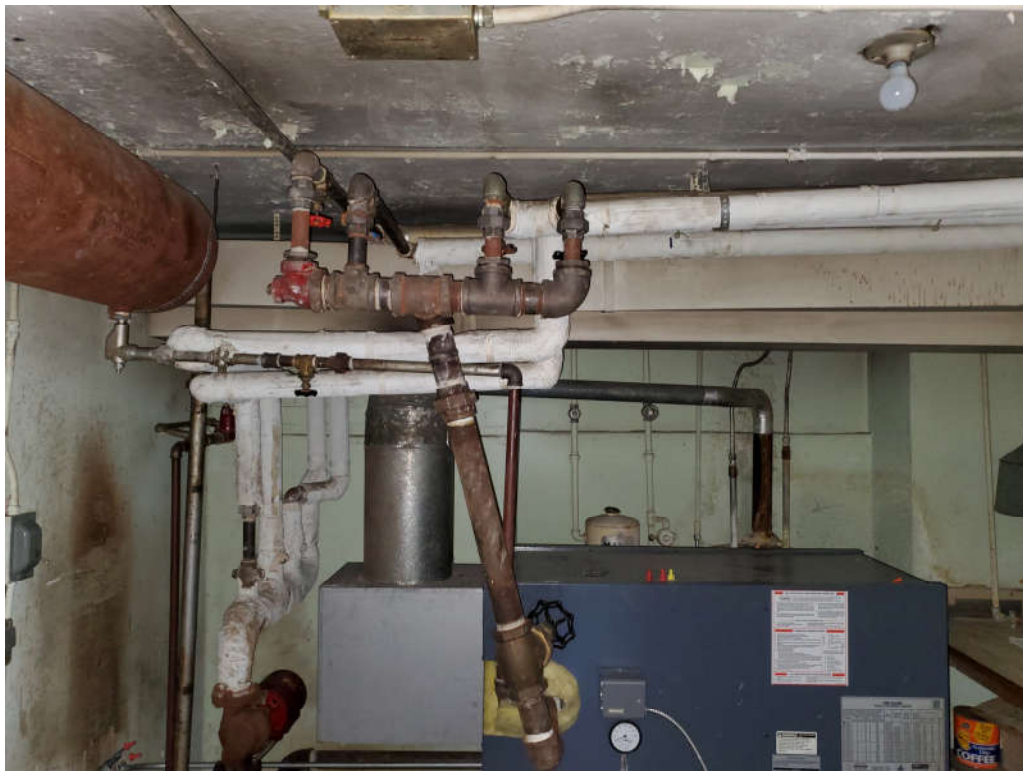
Photo #4: View of pipe insulation (HA 28) and pipe fittings (HA 29) in the boiler room of the office building.

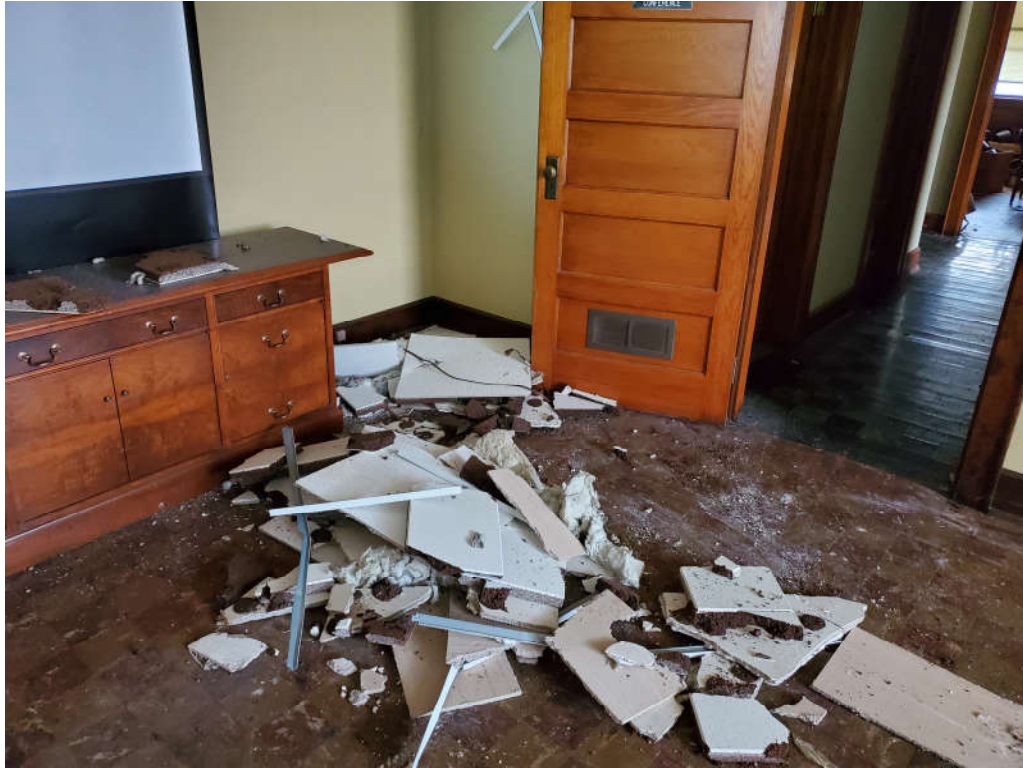
Photo #5: View of the collapsed ceiling tile, ceiling tile mastic (HA 7), brown and light brown floor tile (HAs 1 and 2) in the conference room.

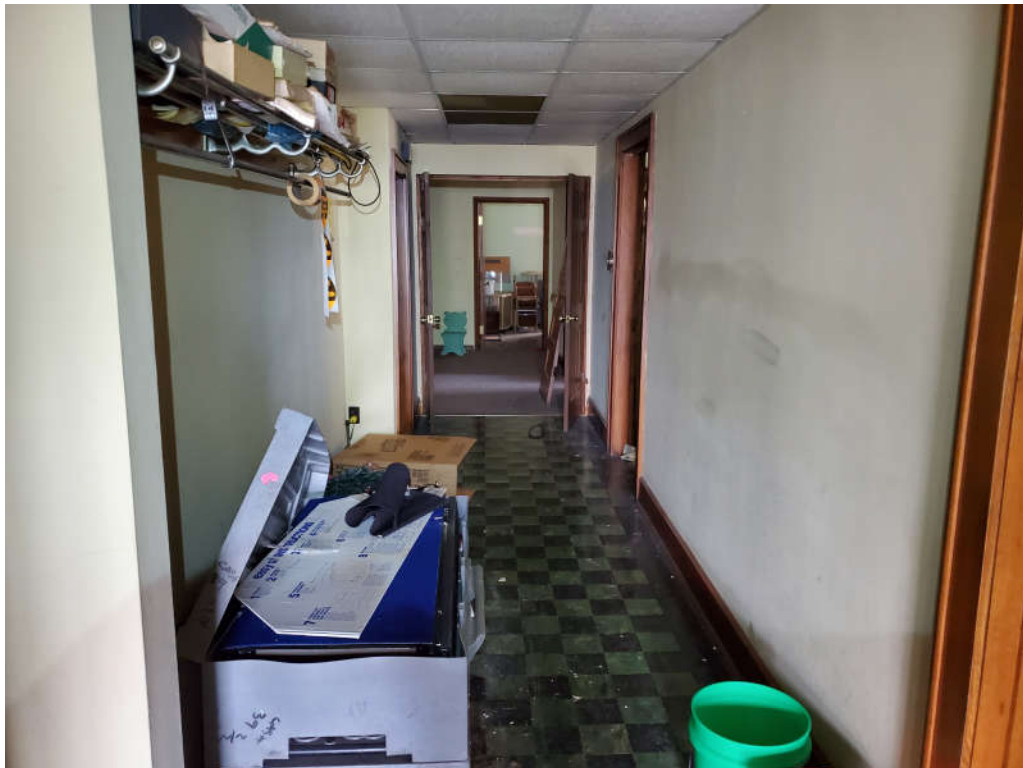
Photo #6: View of black and green floor tile (HAs 9 and 10) and 2'x4' black floor tile (HA 19) in the hallway.

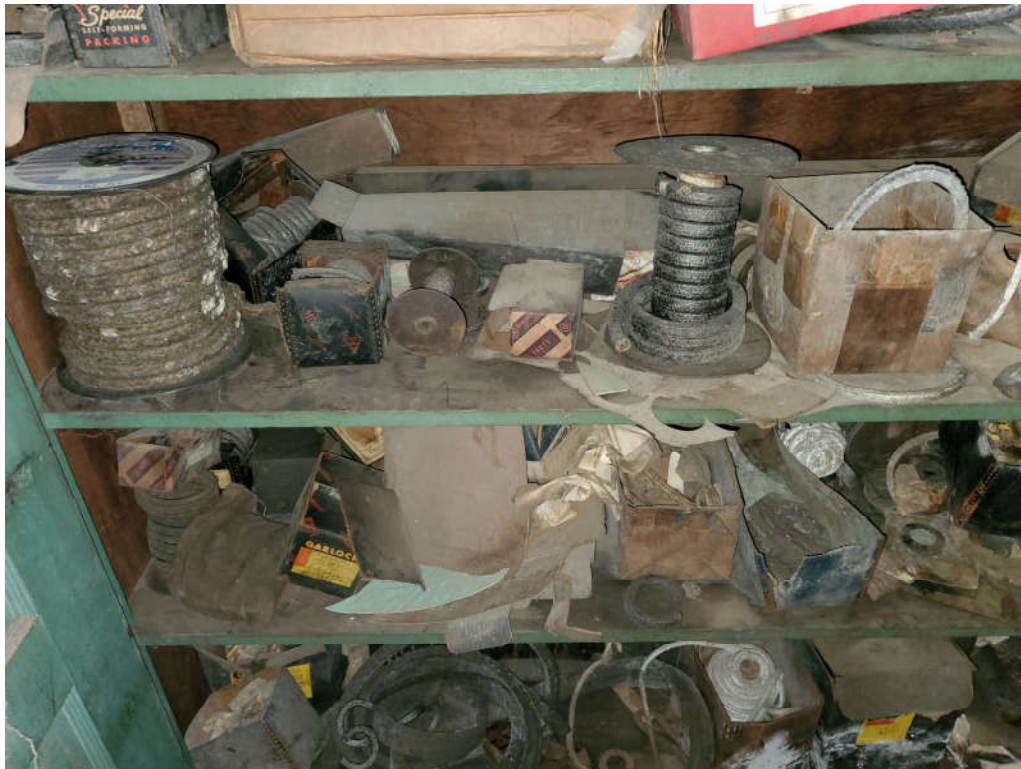
Photo #8: View of storage cabinet with multiple packings and rope insulation (HA 43).

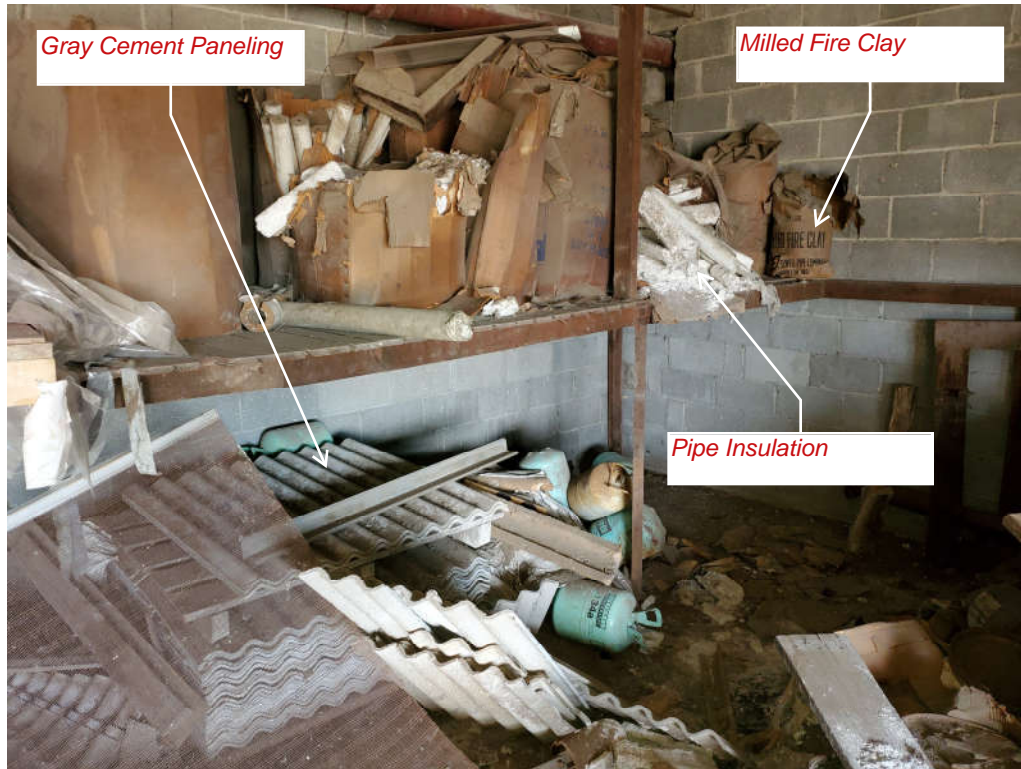
Photo #11: View of gray cement paneling (HA 51), white pipe insulation (HA 53), and gray milled fire clay (HA 54) in the Garage 6 of the storage building.

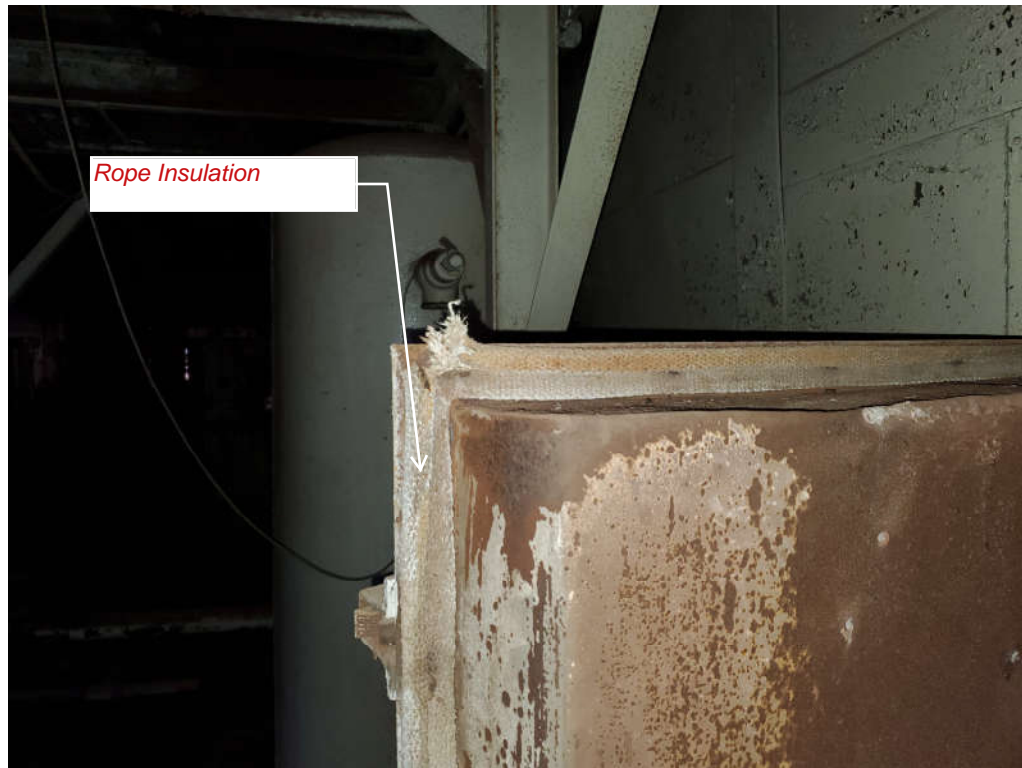
Photo #13: View of white rope door insulation (HA 69) in the joint building.

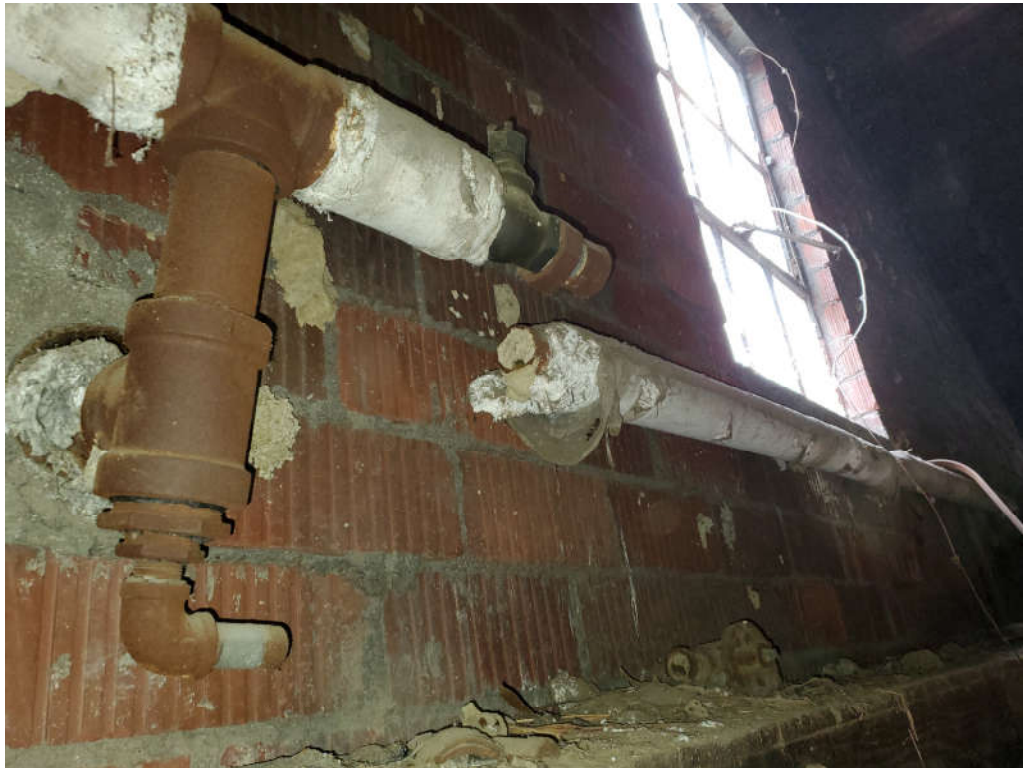
Photo #15: View of pipe insulation (HA 92) in the old machine shop.

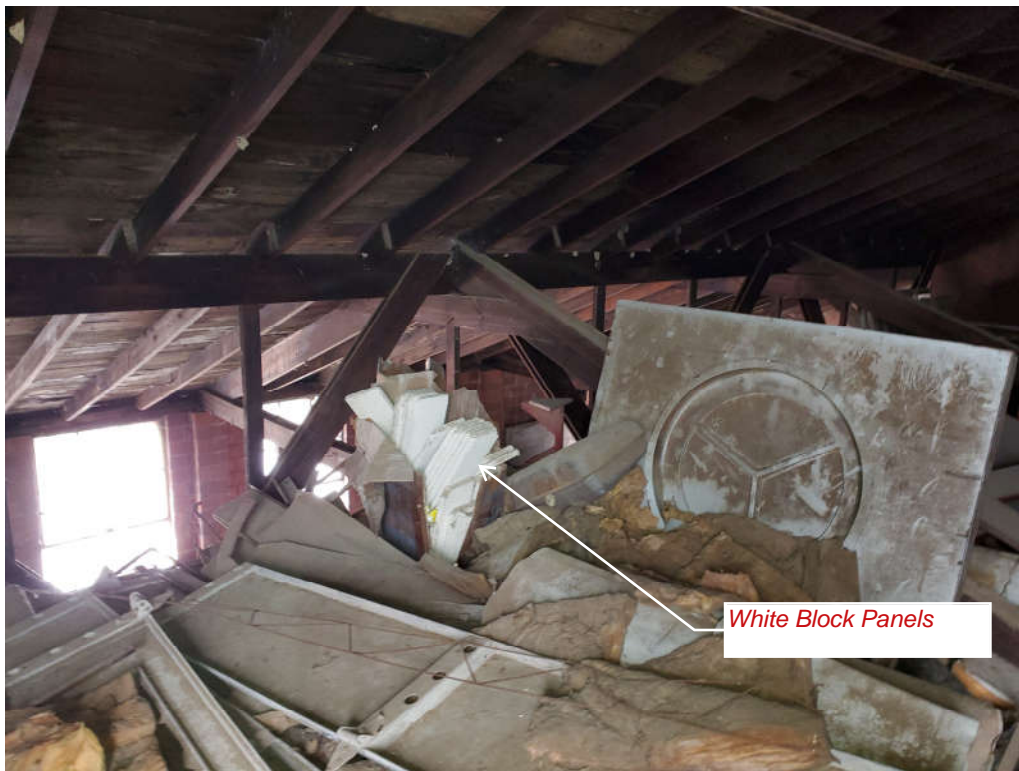
Photo #16: View of white block panels (HA 93) in the old machine shop.

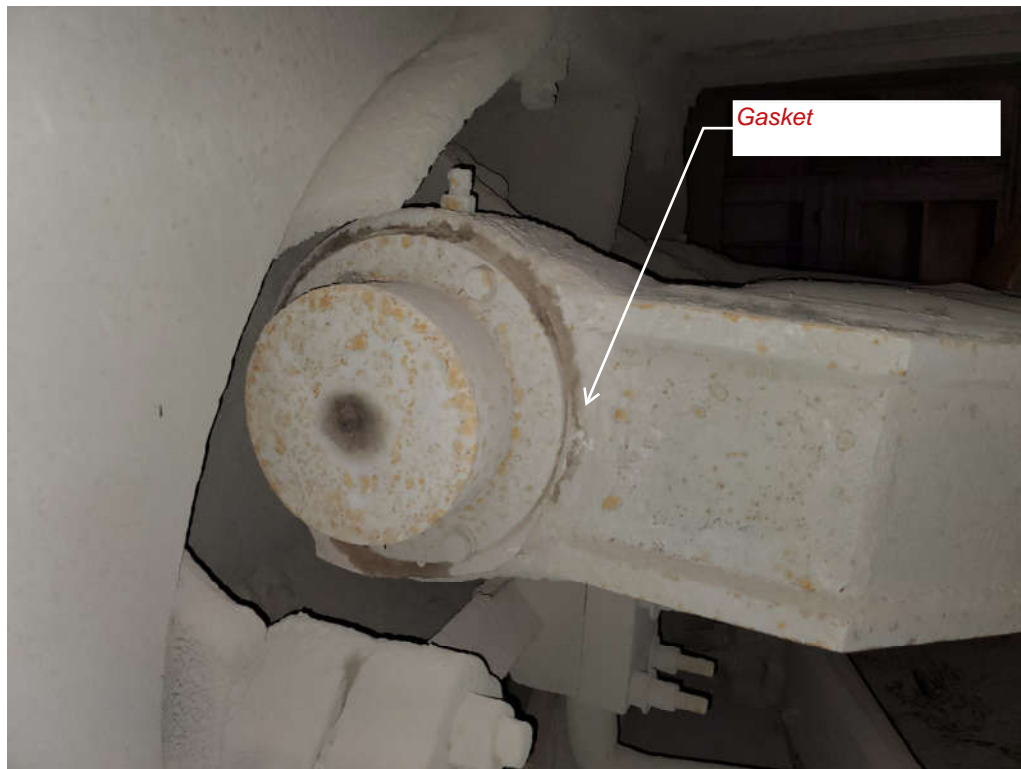
Photo #18: View of machine gasket (HA 61) in the clay shed.

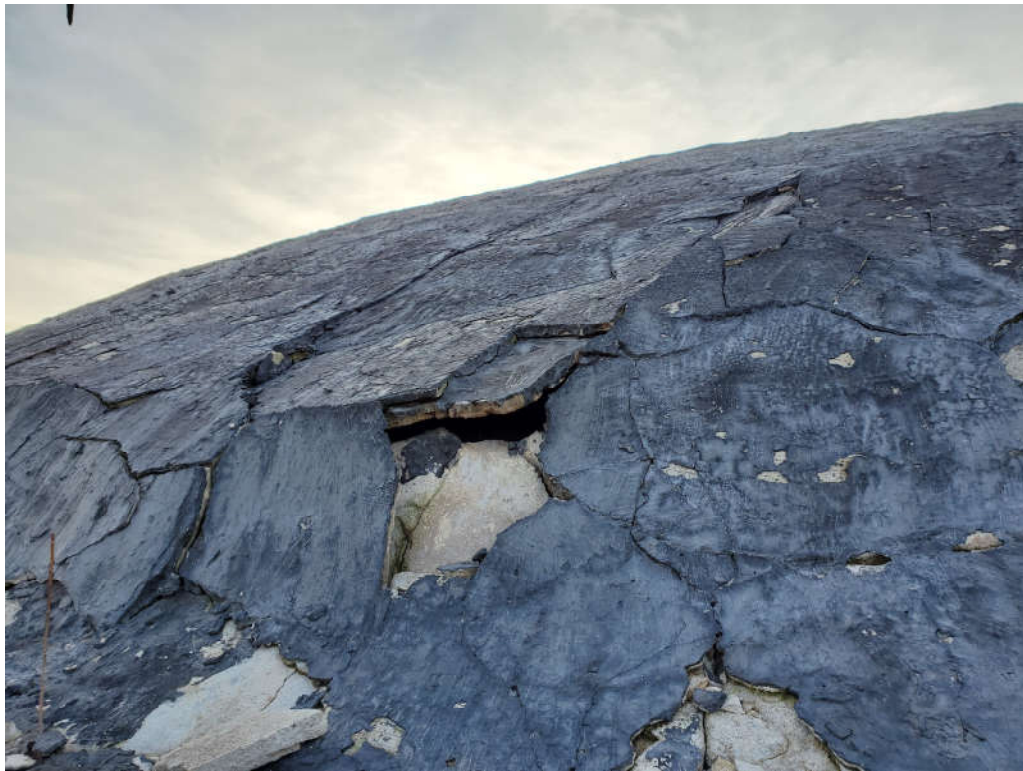
Photo #20: View of gray/black kiln roof (HA 73).

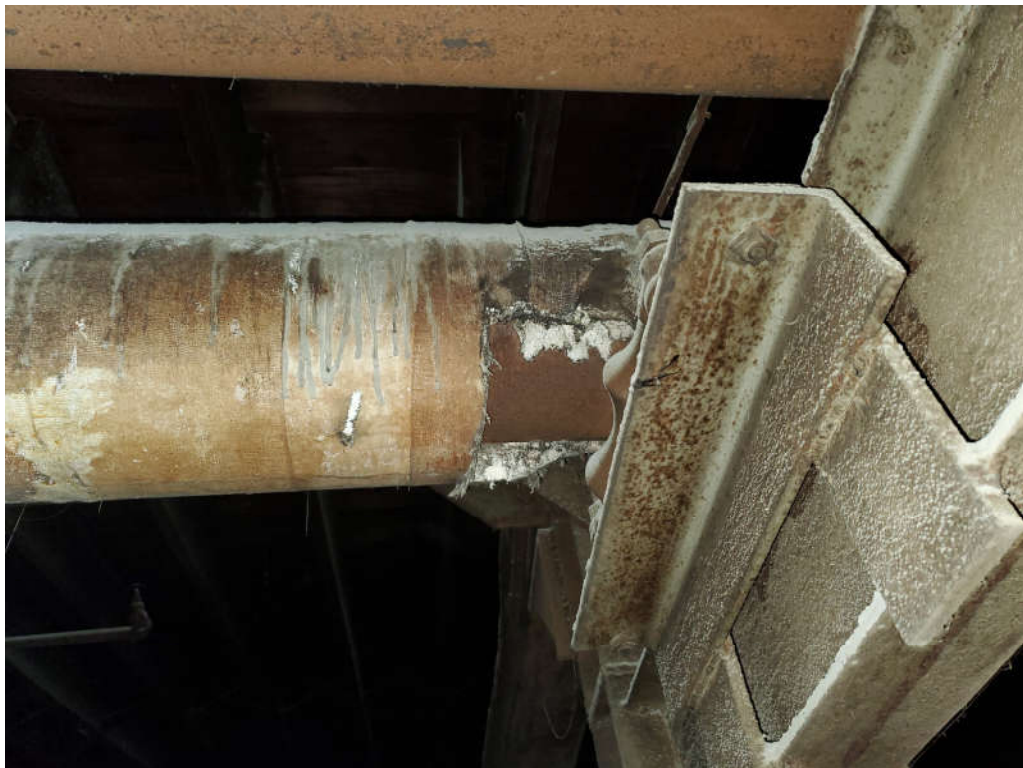
Photo #26: View of pipe fitting (HA 98) in the production building.

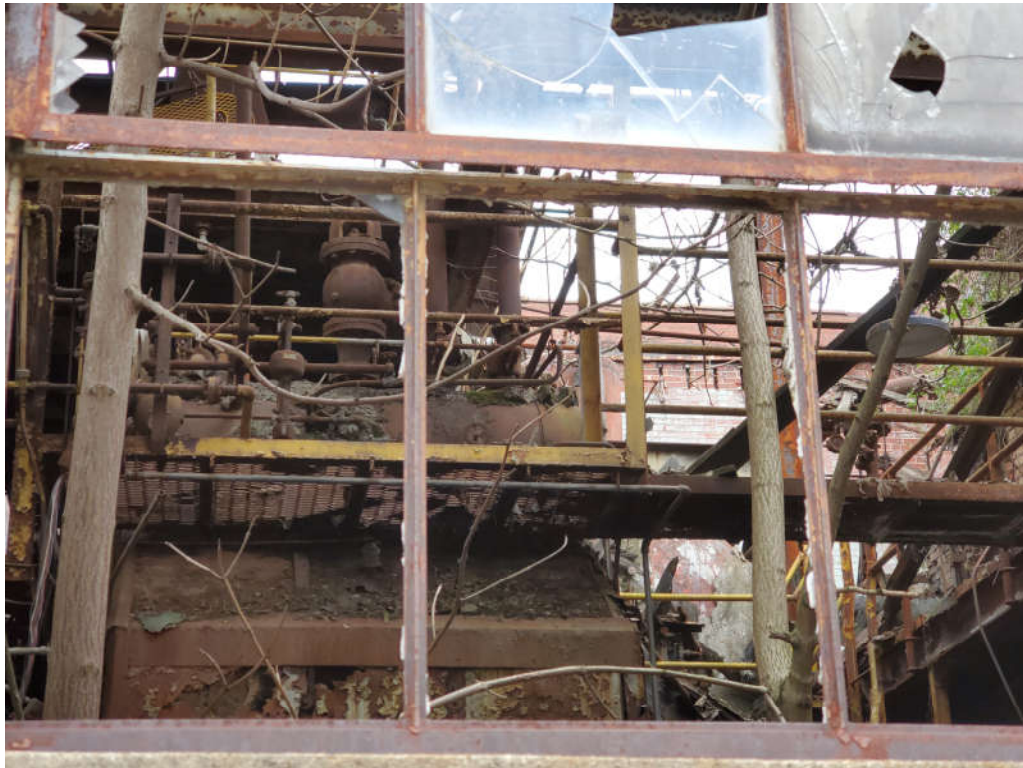
Photo #27: View of boiler room and gray boiler insulation (HA 113) in production building as viewed from window.

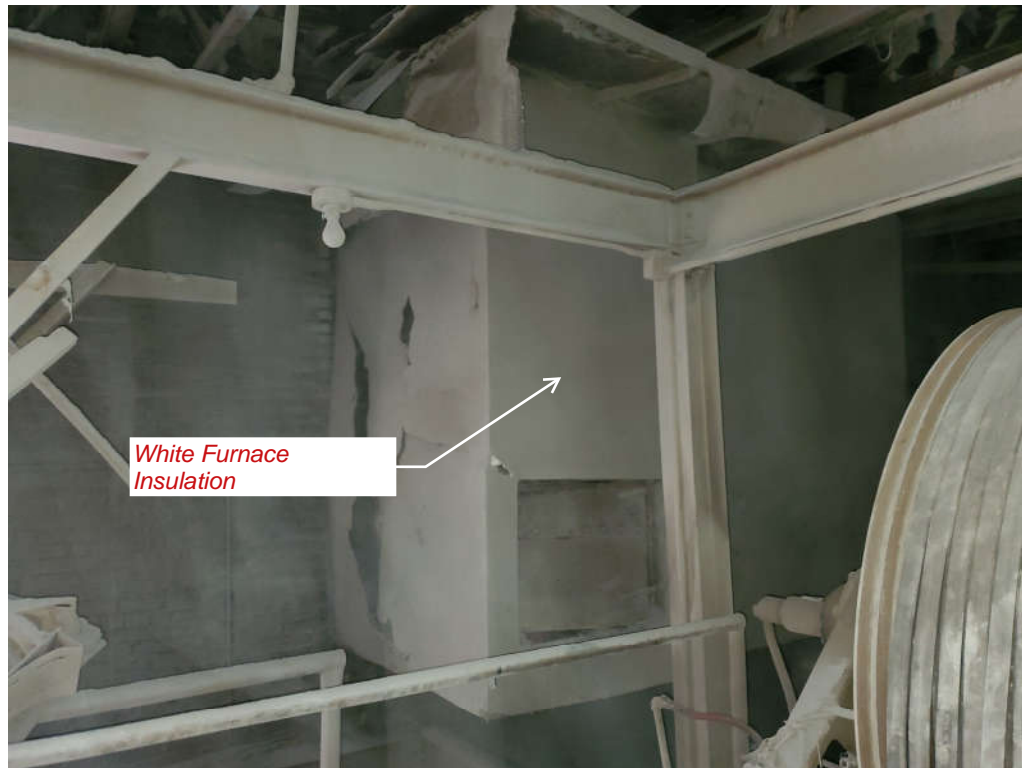
Photo #29: White furnace insulation (HA 102) in the production building.

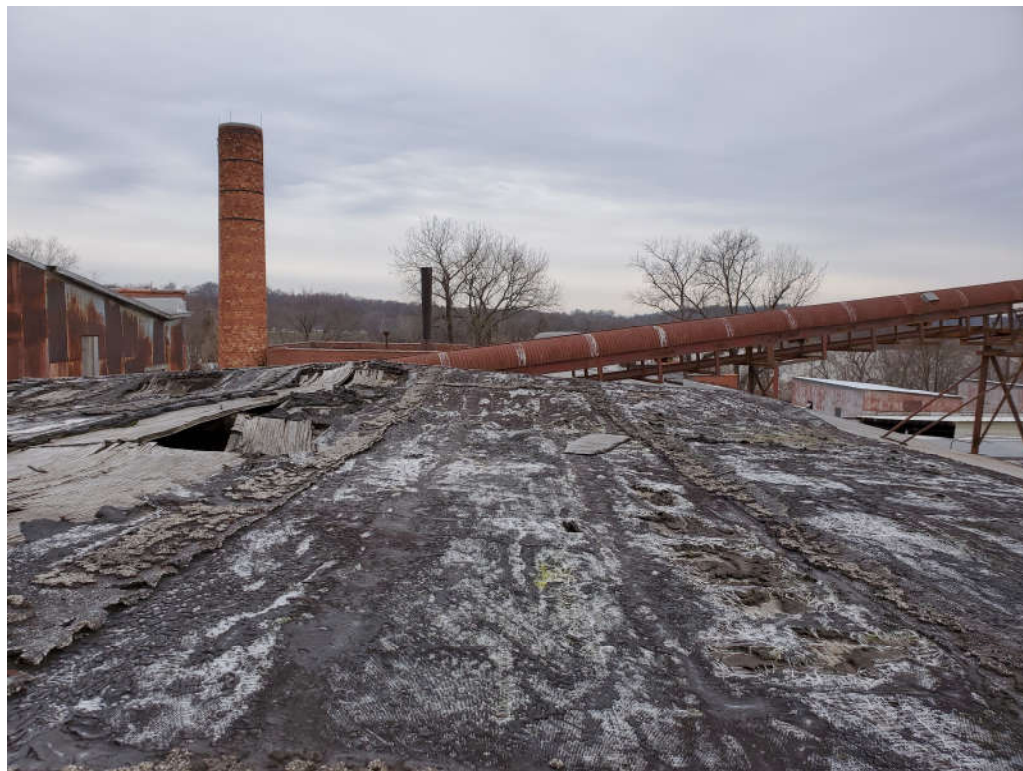
Photo #30: View of asphalt roofing material (HA 106) on a portion of the production building.
